Oculus Rift Development Kit 2 Cable Hub Replacement

This guide leads the user through the replacement steps for the Oculus Rift Development Kit 2 cable hub.

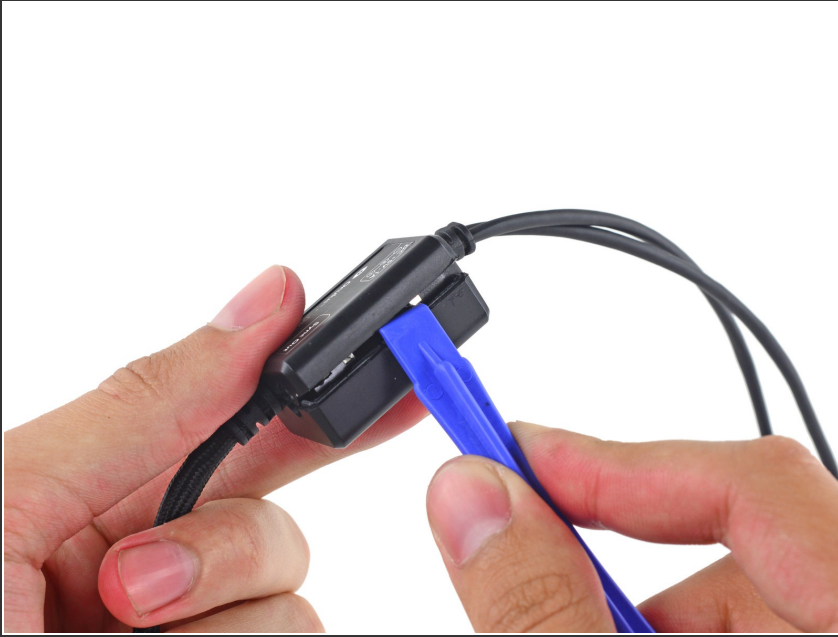
Step 1 — Cable Hub

- Using the plastic opening tools, pry open the cable hub.

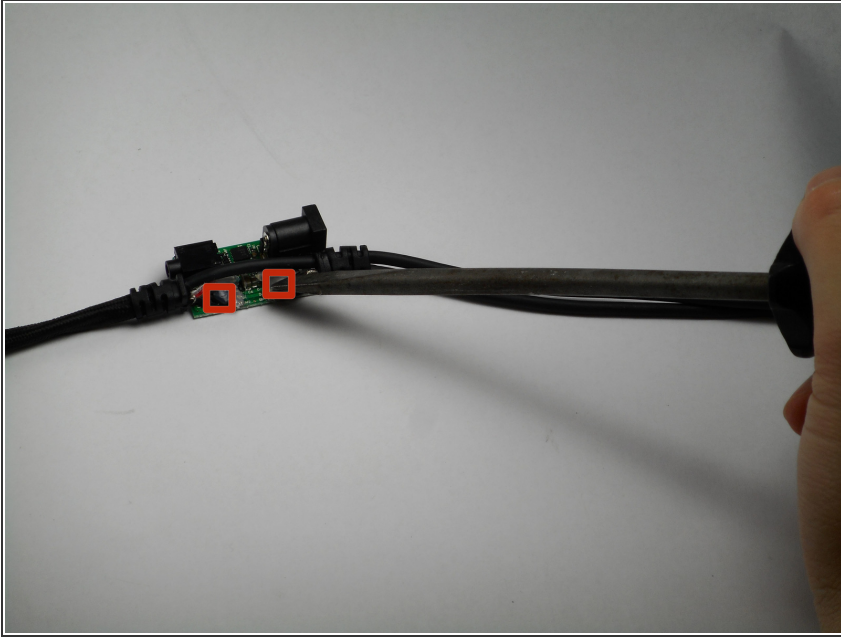
Step 3

- Desolder the wires as illustrated. This can be done by heating up the solder connecting the board and the wire. When the solder is liquified, pull the wire away from the board.
- ⓘ Need some help? Follow this [guide](#) to learn soldering basics.
